Tracking and monitoring of elephant movements along the Standard Gauge Railway and highways in the Tsavo Ecosystem, Kenya (March 2016 – June 2017)

About this report: This report is an update of the 6-month report produced in October 2016. It covers observations made between March 2016 and March 2017 of the collared elephants and between July 2016 and June 2017 of the elephants monitored from vehicles and on foot along the SGR. The observations are illustrated using maps, graphs, tables and photos.

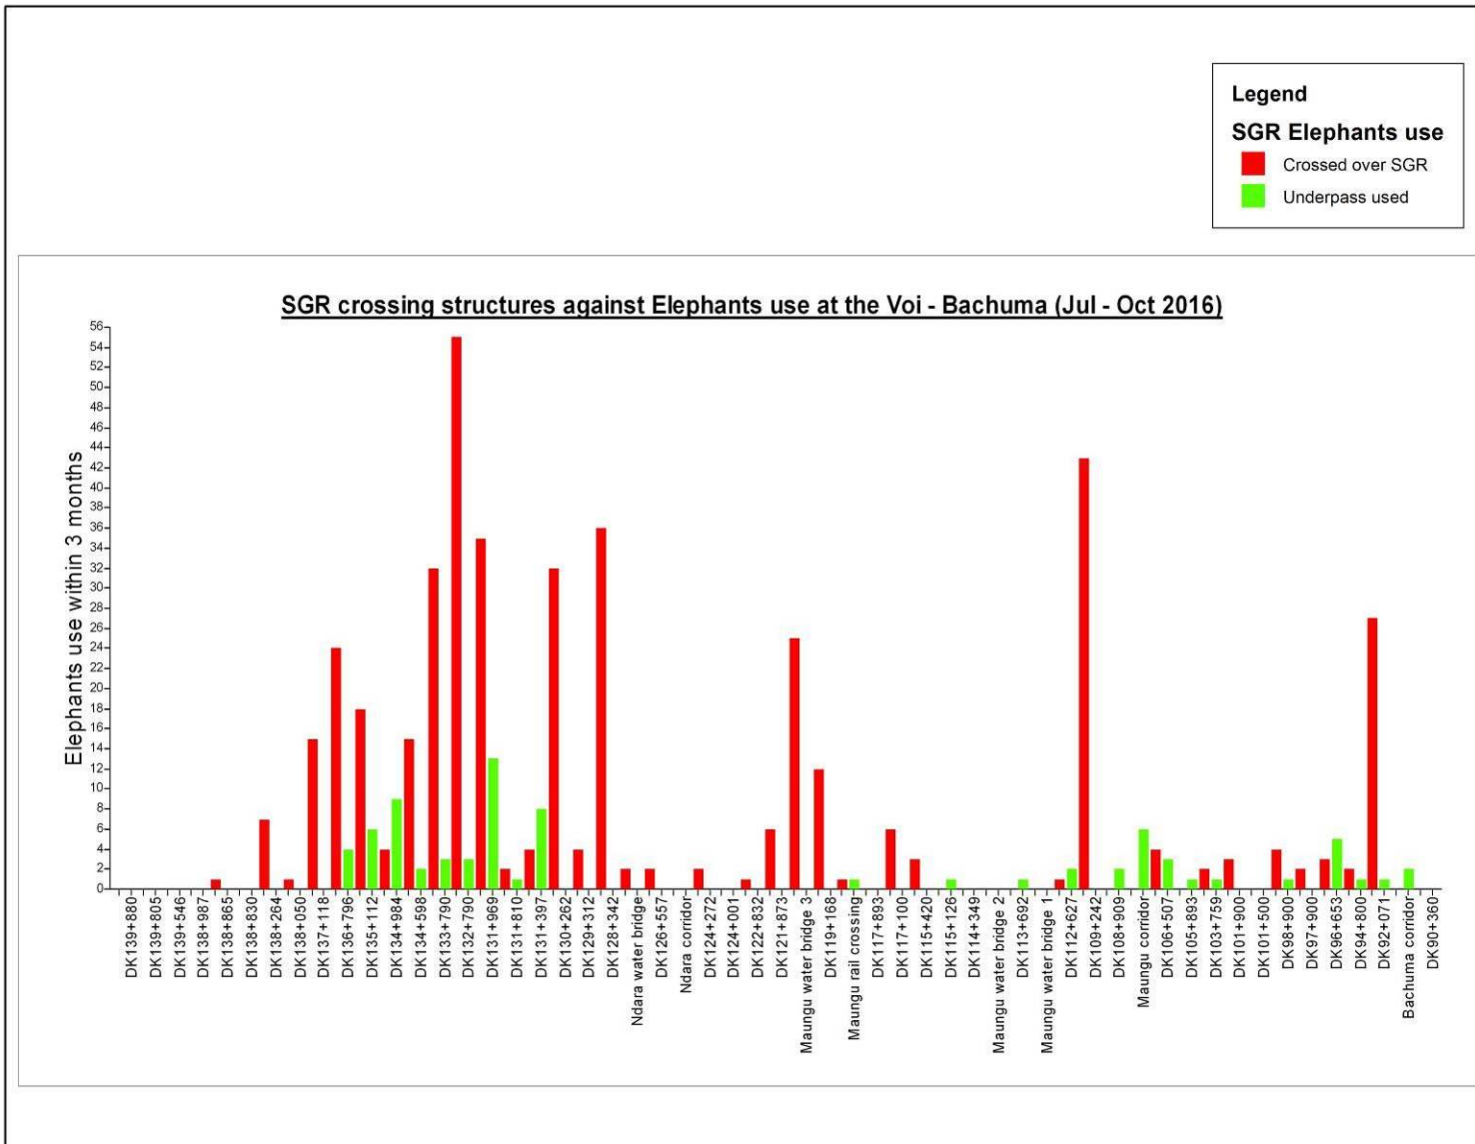
Figure 3a: Elephant – underpass utilization at the Voi – Bachuma, July – October 2016

This section is facing an upsurge of illegal human settlement. The western side of the SGR in some ranches also has human settlements that are gradually blocking the designated SGR underpasses. The high frequency of elephants crossing over the SGR embankment between July and October 2016 (Figure 3a) may indicate a greater need for the elephants to access the habitat on the other side of the SGR. This access between TENP and the Sagalla Ranches was completely blocked by the David Sheldrick’s Wildlife Trust electric fences and the SGR fence between Voi and Ndara area since October 2016 as shown in Figure 1a. These two parallel fence lines were completed around October 2016 and February 2017 respectively, and may explain the observed decrease in the number of elephants who crossed the SGR via the embankment between the park and Sagalla. The double fencing at Ngutuni also completely

blocks elephants from utilizing the culverts in this area. The animals seem to have shifted to use the previously underutilized designated underpass at Ndara (see Ndara corridor in Figures 3a & 3b). However, human-elephant conflict is imminent at this particular underpass given the increasing illegal settlements directly under and around the main Ndara elephant underpass (Plates 1a & 1b). A presence of charcoal for sale has also been observed from these illegal road side settlements. It is recommended that these new and illegal settlements are moved as soon as possible to pre-empt any human-wildlife conflict incidents from occurring in this main Ndara wildlife corridor.

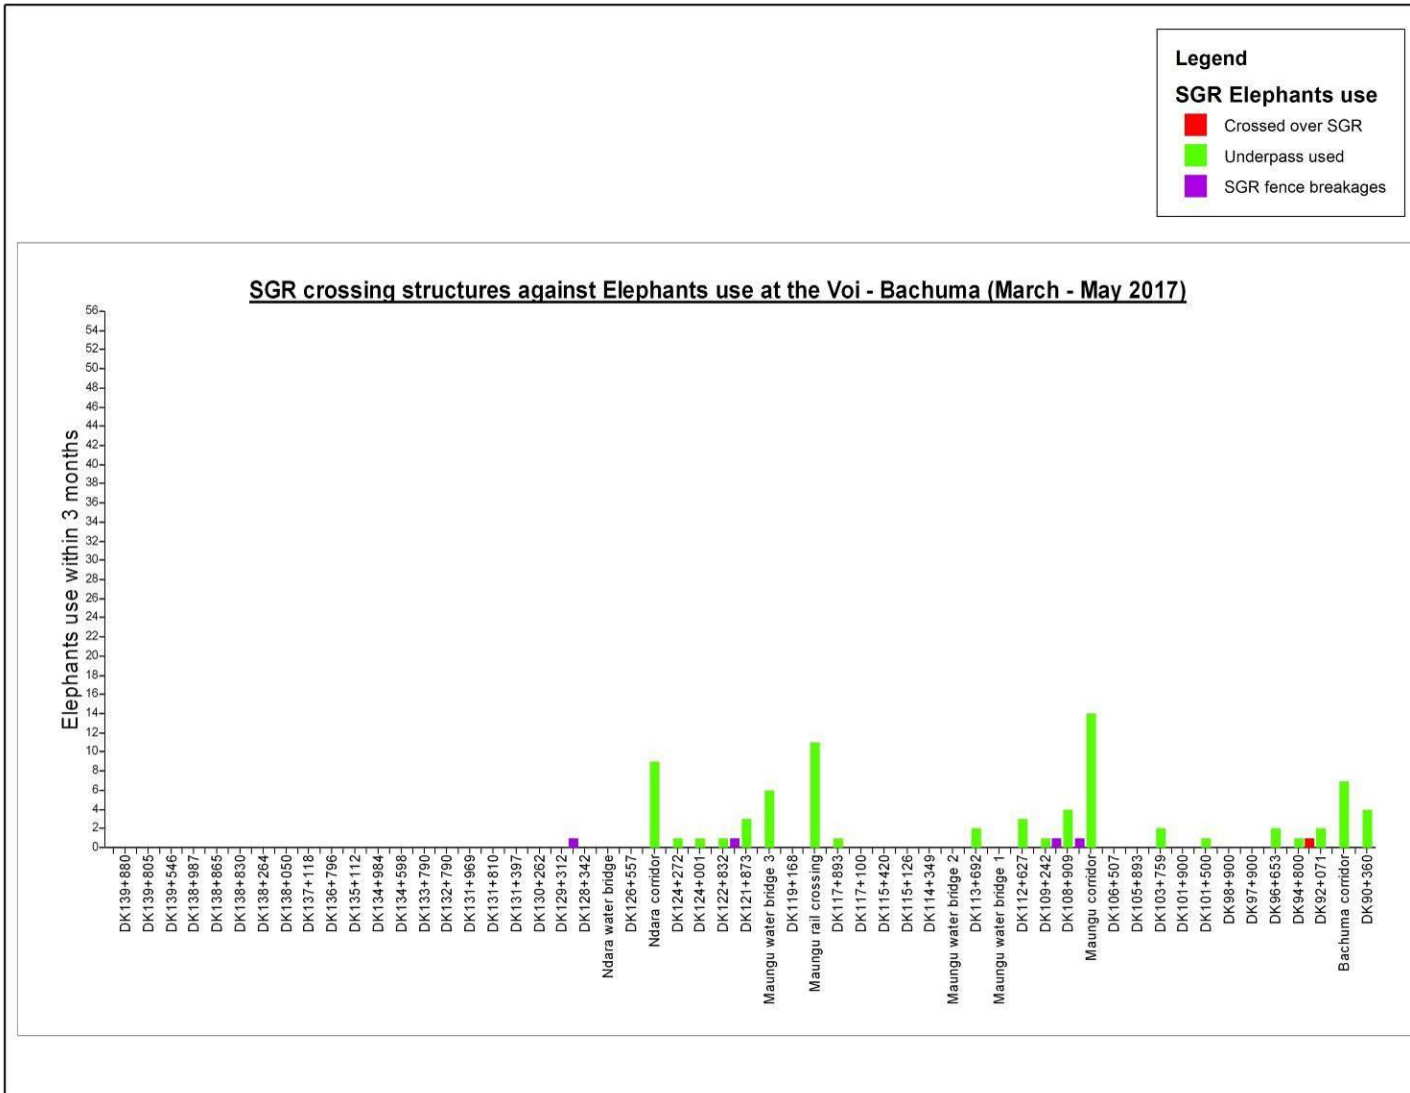
Figure 3b: Elephant – underpass utilization at the Voi – Bachuma, March – May 2017

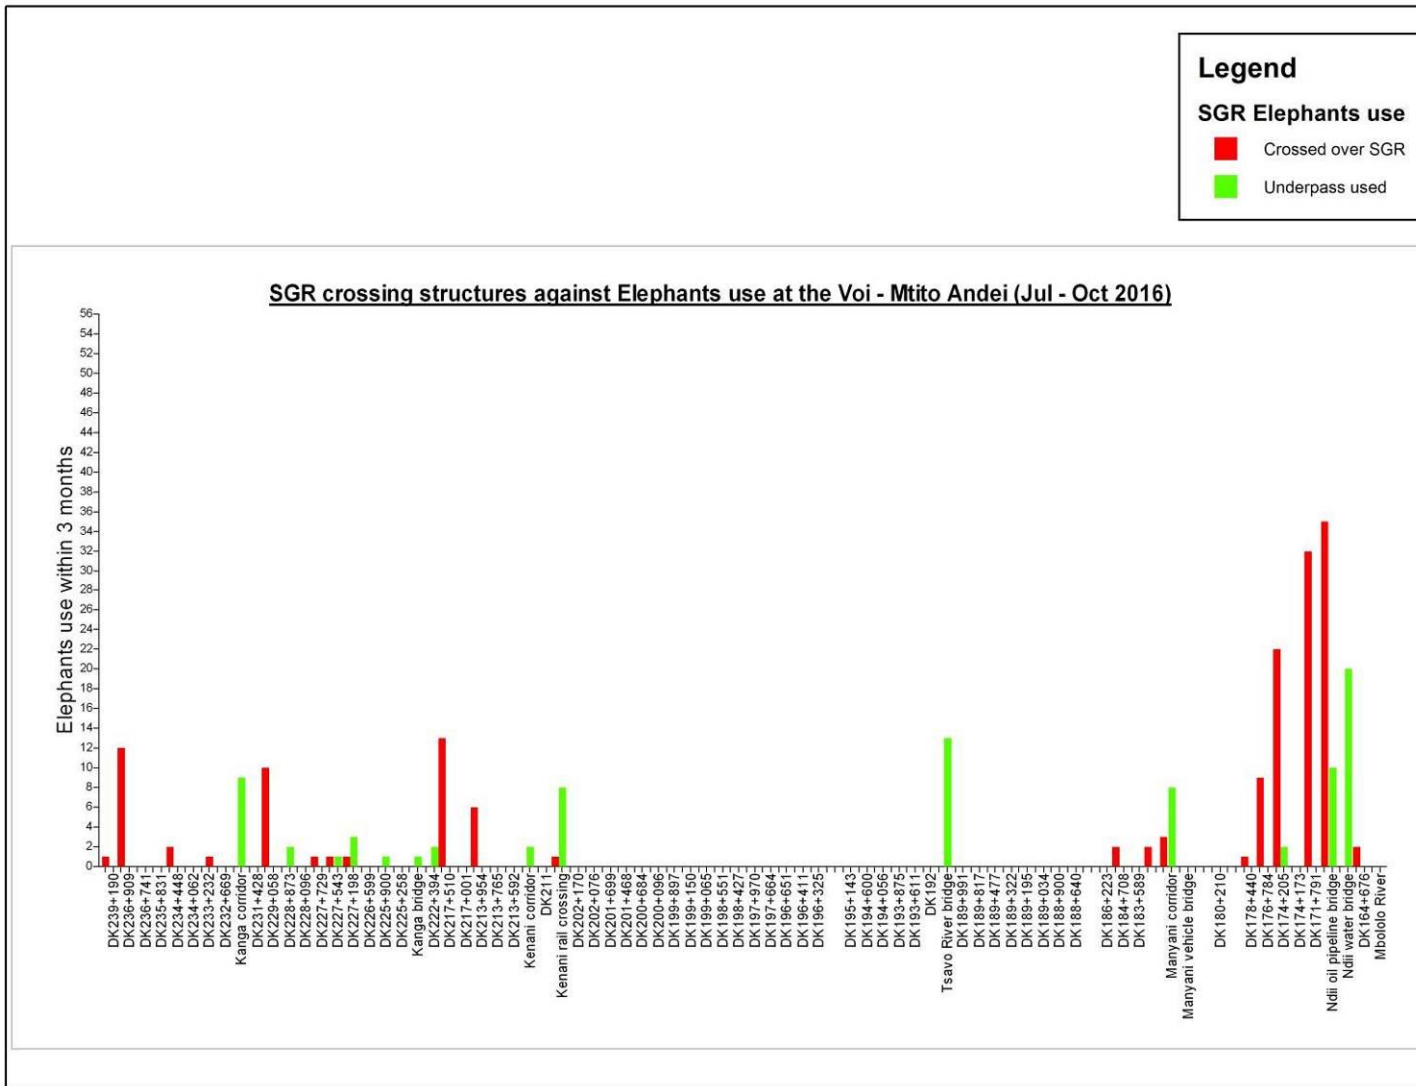
Figure 3c: Elephant – underpass utilization at the Voi – Mtito Andei, July – October 2016

There was an exponential increase in the frequency of underpass usage between March – May 2017 compared to between July – October 2016 (See frequency of use of corridors in Figures 3c & 3d). We could infer that elephants adapted reasonably quickly to the underpasses and particularly after the SGR fence was erected. This inference may be supported by the recorded decrease in the frequency of crossing the embankments in the same period.

Strikingly, the culverts between Kenani rail crossing and Manyani were not been utilized in both periods of monitoring (Figures 3c & 3d). This may be due to the high use of Kenani rail crossing and Tsavo River bridges. Animals may have preferred these two wide underpasses to the narrow culverts.

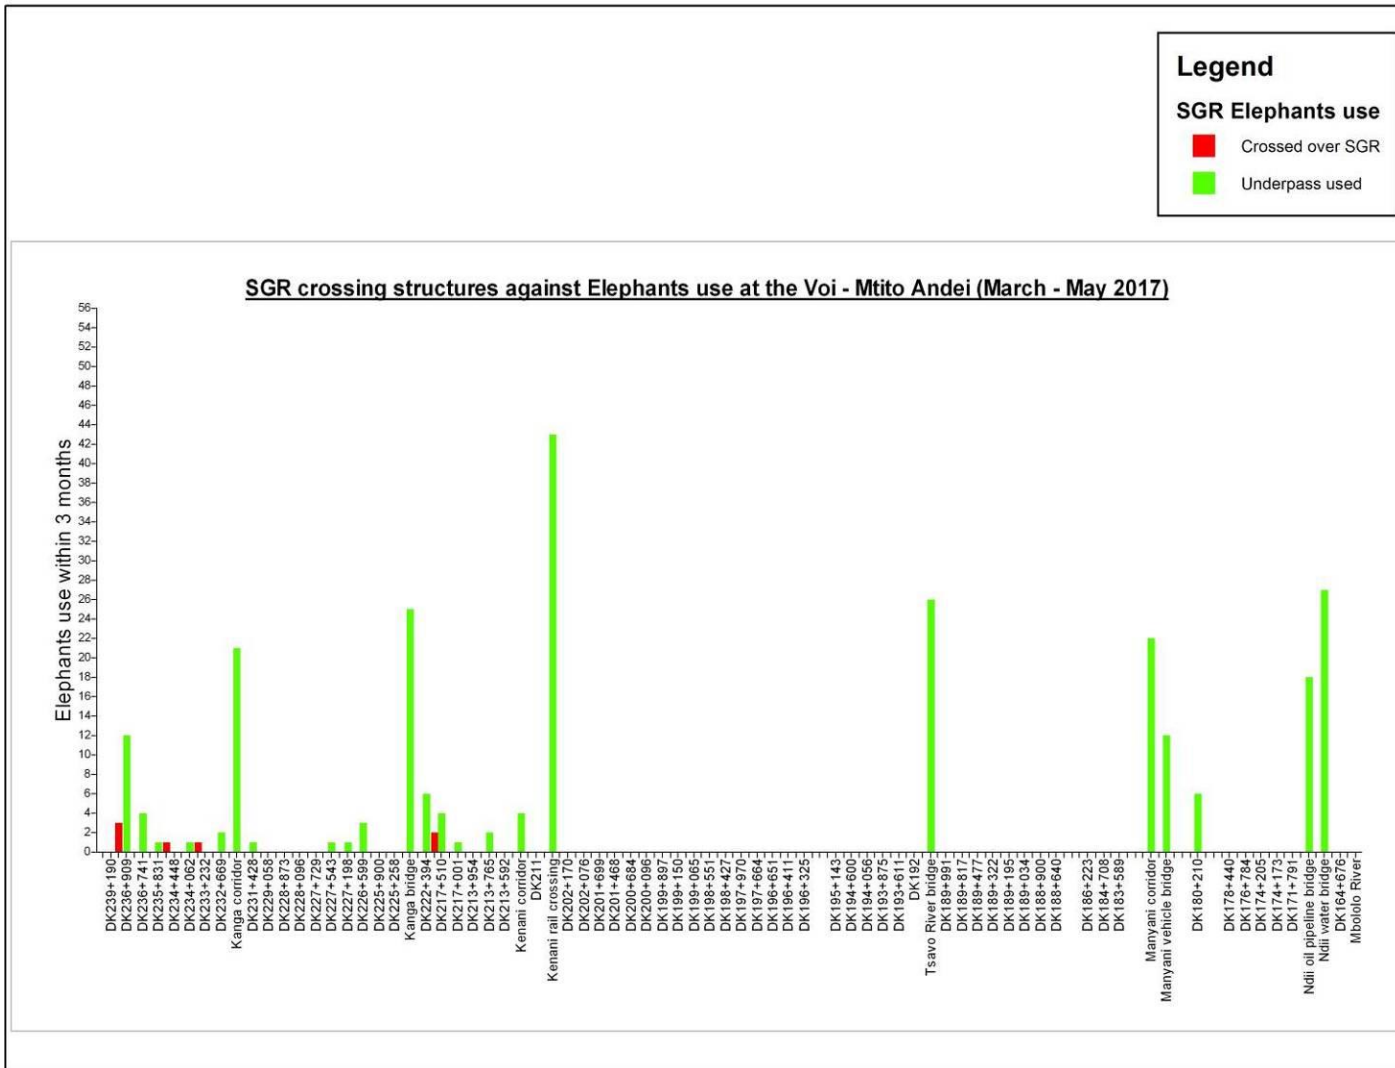
Figure 3d: Elephant – underpass utilization at the Voi – Mtito Andei, March – May 2017.

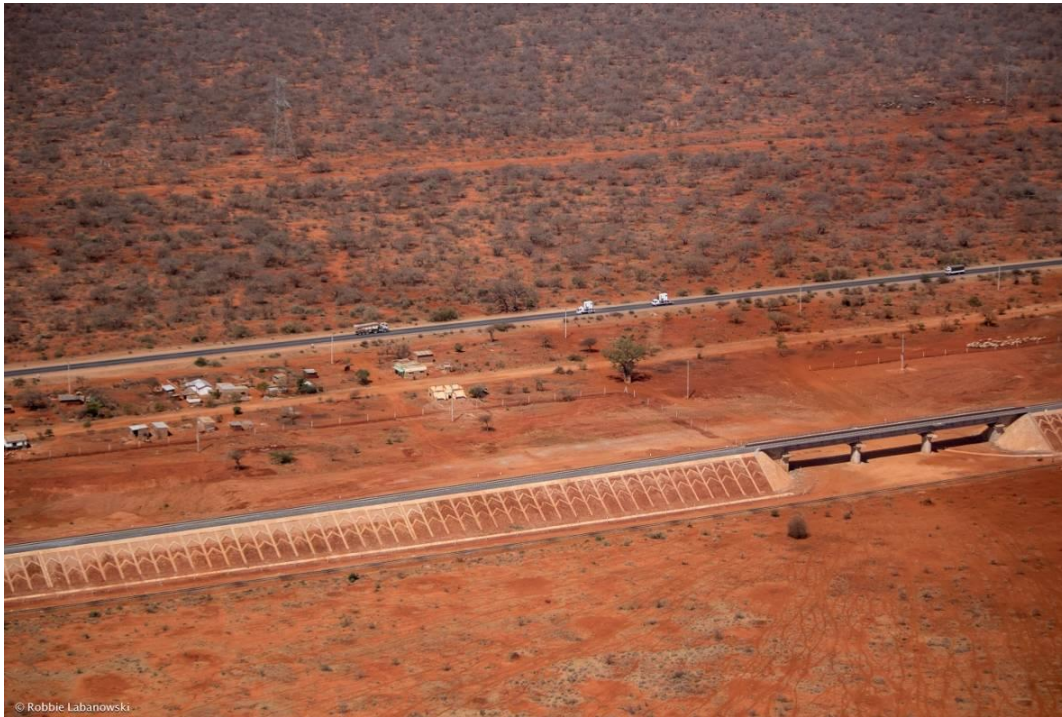
Plate 1a: Illegal Human settlement near an official Ndara corridor underpass at DK125

The blossoming human settlement at Ndara, especially near the underpasses utilized by elephants such as Ndara corridor and Maungu rail crossing (Plates 1a & 1b) obviously have a negative impact on the potential utilization of those underpasses by elephants and other wildlife species. These illegal settlements, and others that can be specified, should be moved from these wildlife passages.

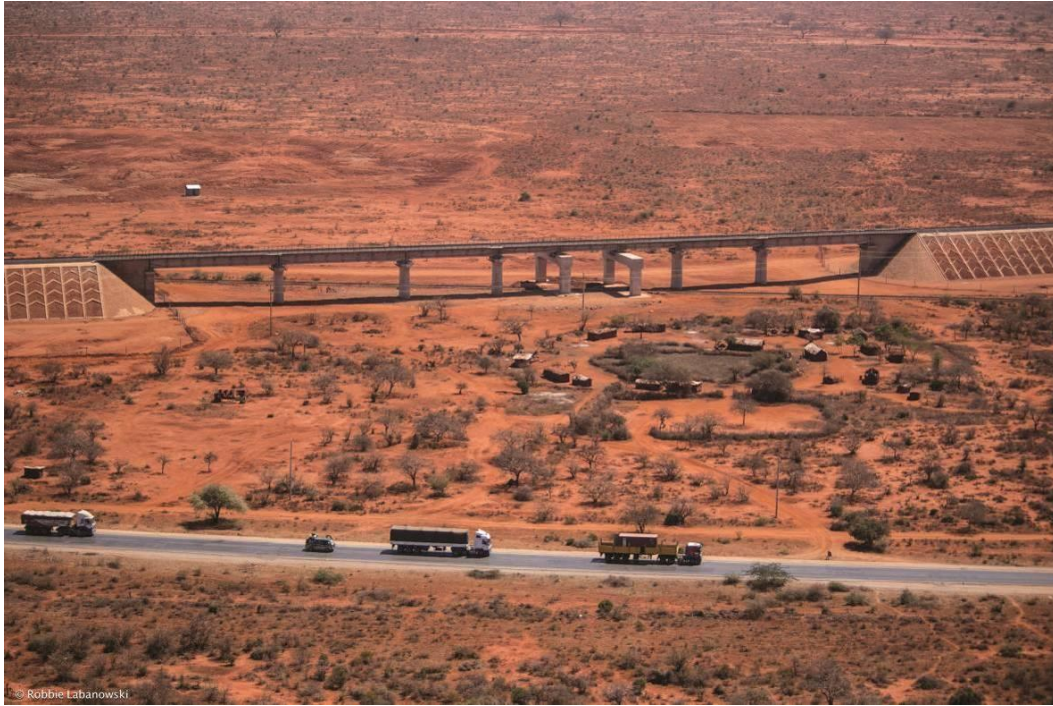
Plates 1b: Recent illegal human settlement at the Maungu SGR and old railway crossing, at DK118, that is highly utilised by wildlife. These settlements will inevitably suffer from human-wildlife conflict and should be moved before they become more permanent.

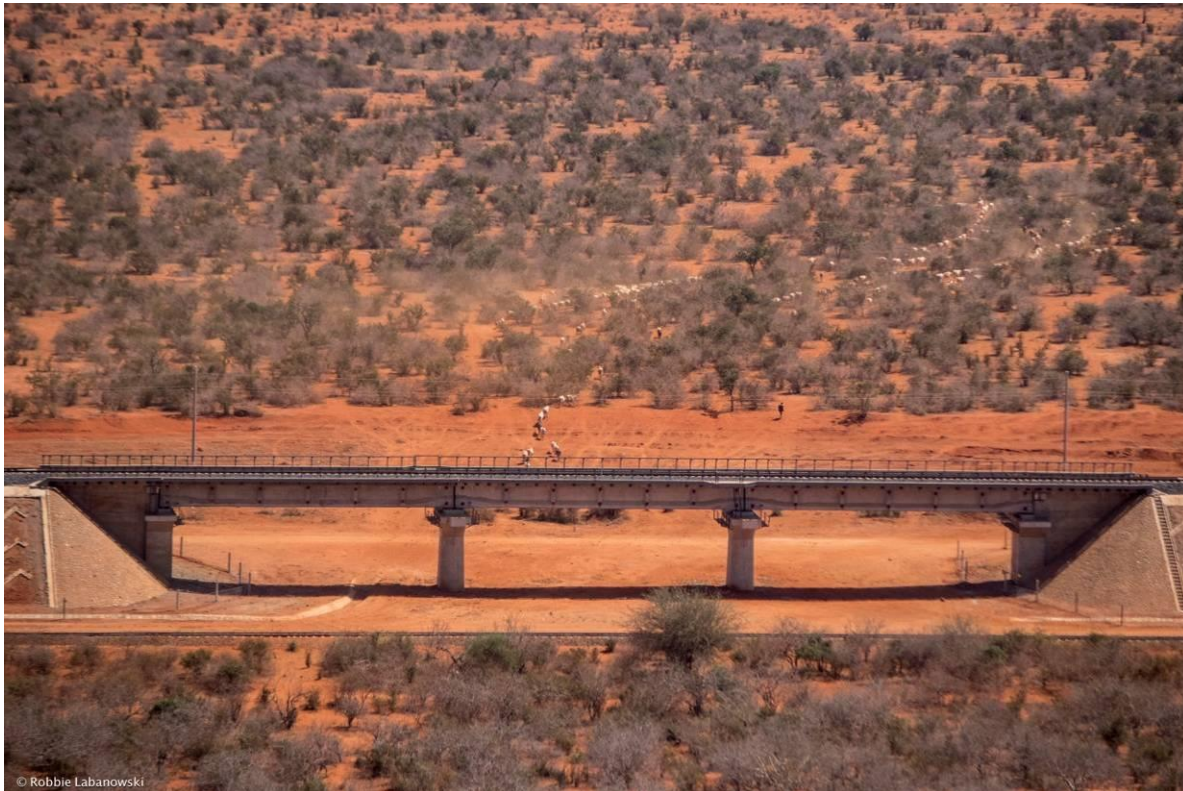
Plate 2: Livestock crossing the SGR into the park using Maungu corridor at DK107

In the course of monitoring the wildlife use of SGR underpasses, it was observed that significant numbers of livestock also use these wildlife underpasses to cross into the Park. In April and May 2017, illegal livestock was recorded to use culverts, bridges and corridors between Ndara corridor and Bachuma corridor as shown in Plate 2 and Figure 5. Stationing of KWS rangers and community scouts at these underpasses would help to stop these frequent illegal livestock movements into the Park. The greater the livestock numbers, the greater the habitat degradation inside the Park which will only encourage elephants to move out into community areas causing conflict. It is opportune that these bottleneck underpasses can be used as a point of blocking livestock incursions into the Park.

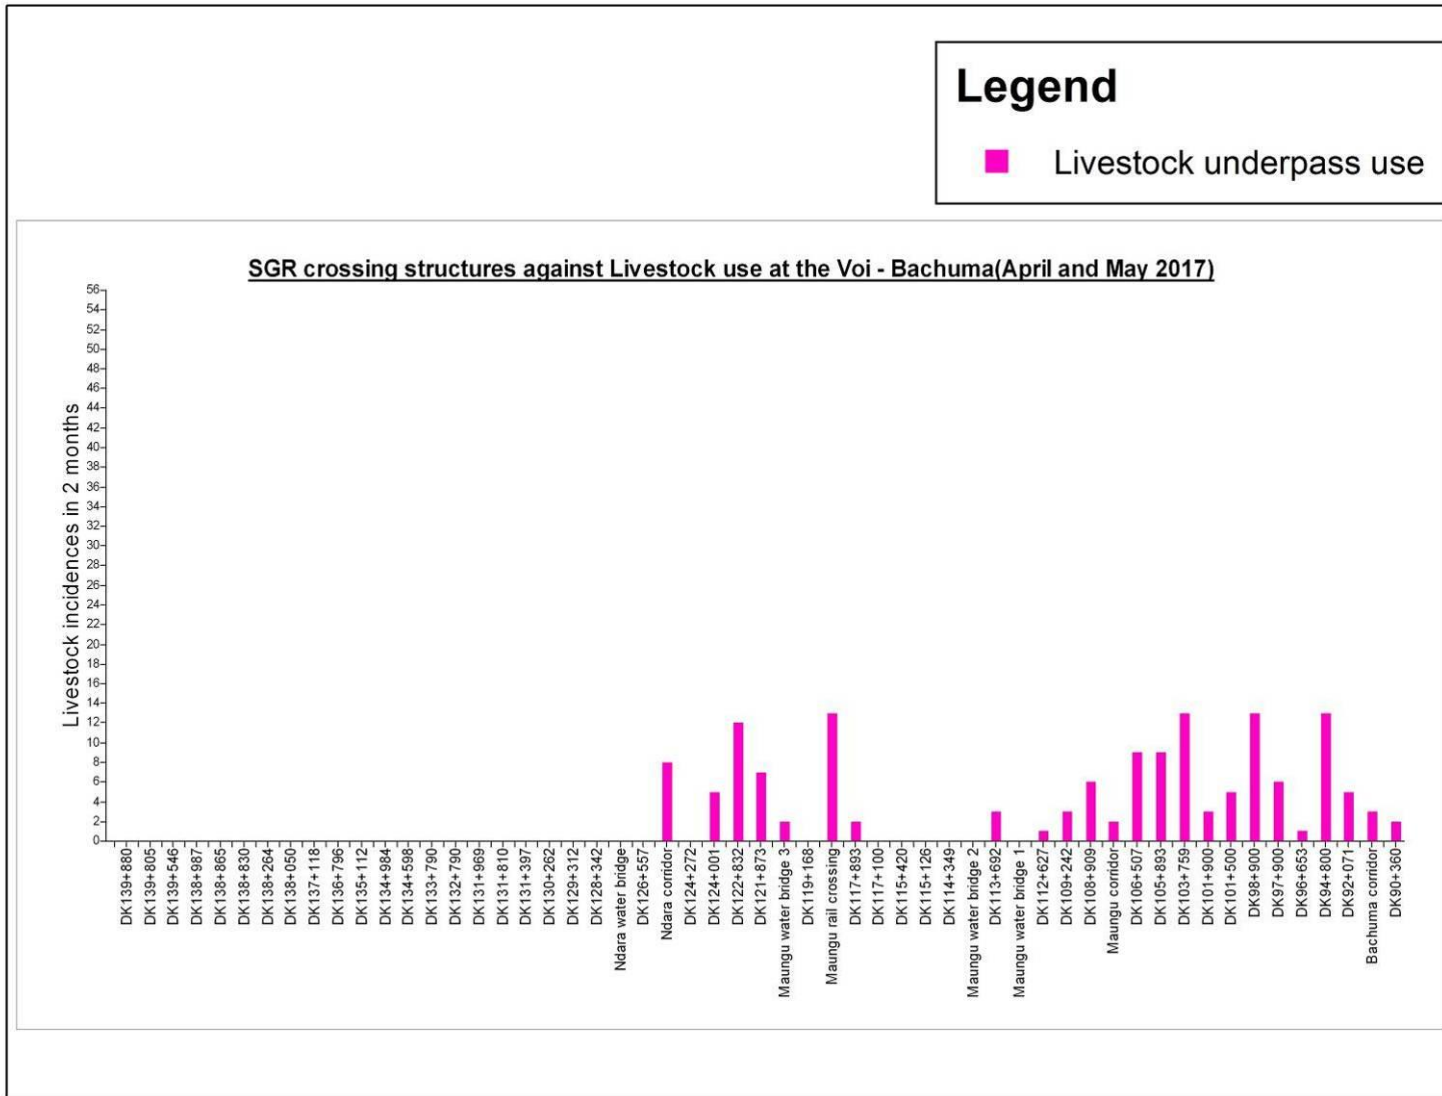
Figure 5: Graph showing the frequency of livestock using underpasses between Voi and Bachuma in April and May 2017

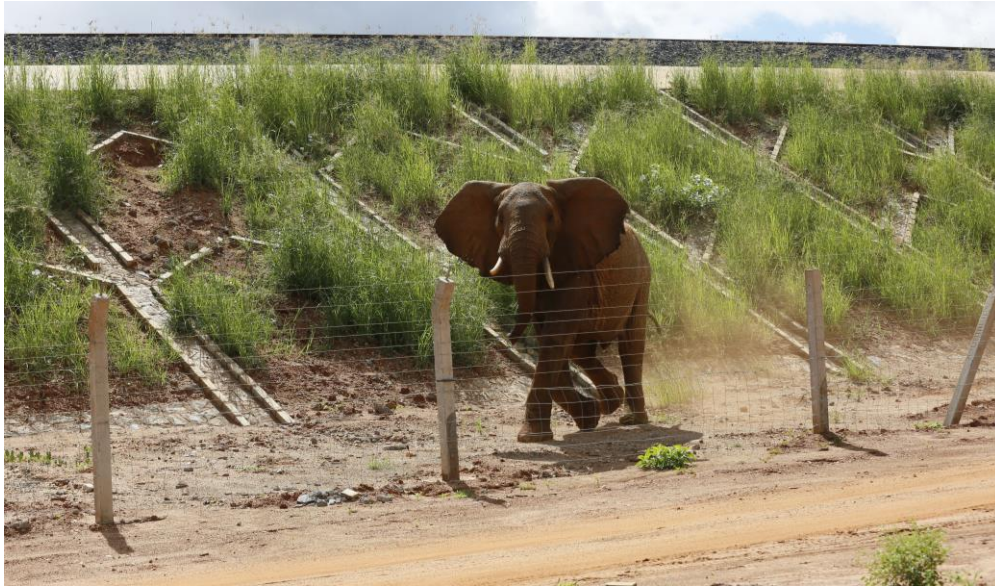
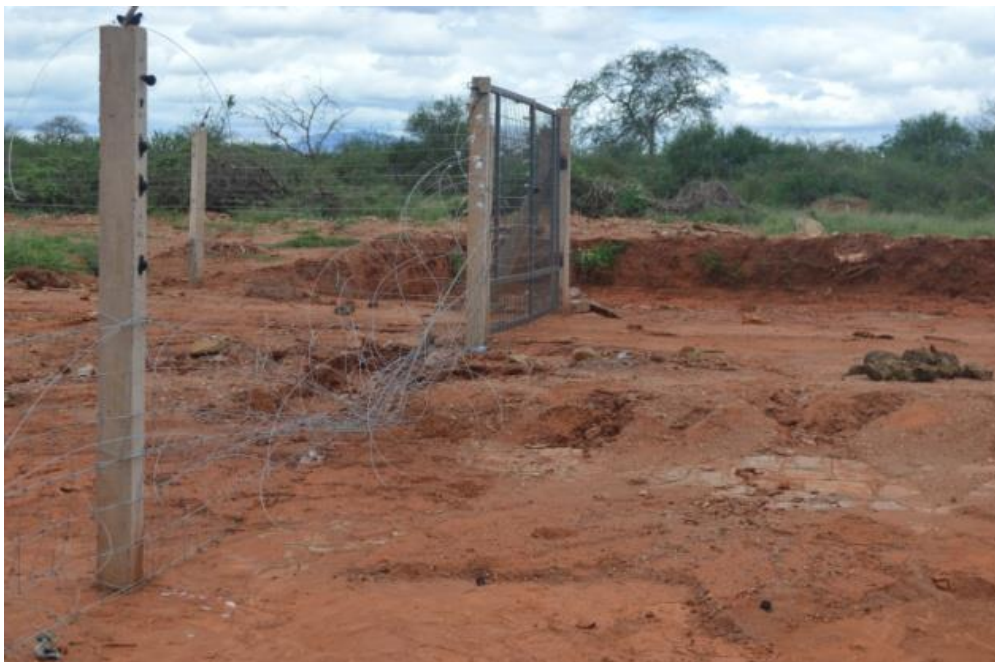
Plate 3a & 3b: Trapped elephants inside the SGR fence and breakages by elephants creating a high risk for collision between elephants and the SGR train. *Photo Credit: Tsavo Trust and KWS*

Elephants were observed breaking through the SGR fences in April and May 2017. This may be due to the fact that the fence was not yet powered by electricity. But it gives a glimpse of the likely disastrous scenario in case of power outages when elephants could easily break the fence and climb up onto the railway tracks (Plates 3a & b). The fences are presently not regarded as elephant-proof and must be brought up to wildlife proof standards and maintained with consistent electrical current to ensure no accidents occur between wildlife and the SGR trains.

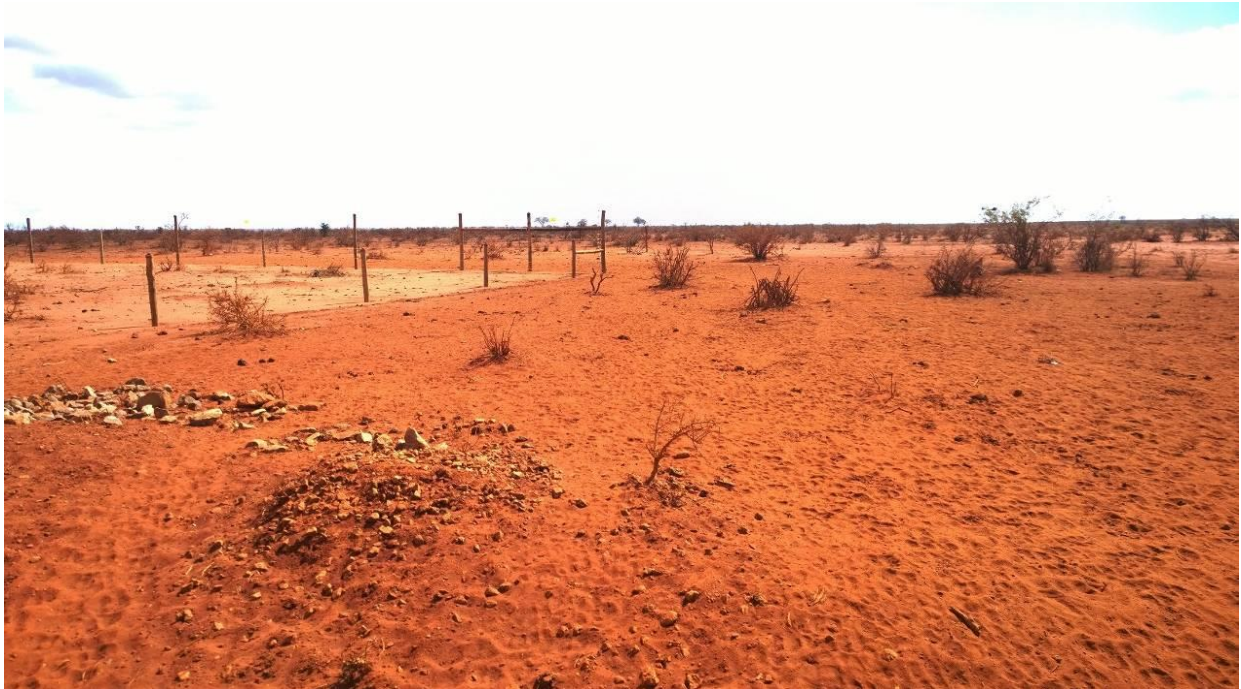
Plate 4: Habitat degradation at the Ndara underpass caused mainly by excessive use by cattle entering and exiting the park through this corridor. *Photo Credit: STE*

Given the restricted movements of wildlife to particular underpasses and the illegal herds of thousands of cattle using the same underpasses to access grazing in the park. Habitat degradation around the underpasses is looming. Mitigation measures will have to be put into place to restrict livestock movements and ensure the land is restored with natural vegetation to avoid extensive soil erosion.

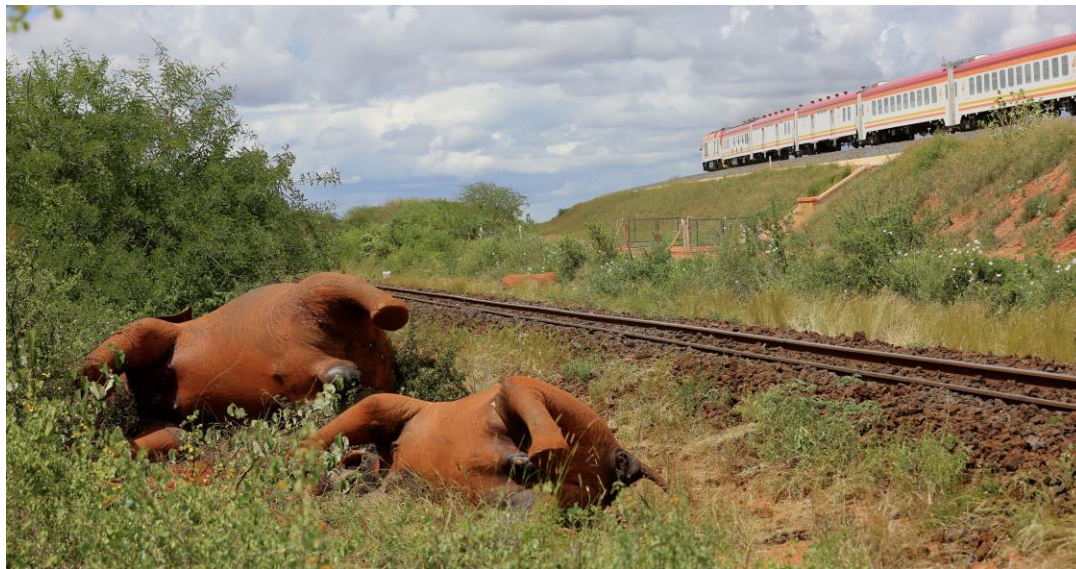
Plate 5: Three adult elephants (third one partially visible in the center of the picture) killed by train on the old railway line on 9th May 2017 around the Kanga area. Elephants crossing the old rail line panic when they get trapped between the old line and the SGR fence. *Photo Credit: Tsavo Trust*

A total of 20 elephants (11 by train, 8 by vehicle and 1 by electric shock) were killed along the transport corridor in Tsavo East and Tsavo West National Parks between January 2016 and June 2017 (Figure 6, Plate 5 & Table 3). Those killed by trains were mainly due to the elephants getting trapped between the old railway and the new SGR fence with no alternative exit route. We recommend that the SGR fence incorporate the old railway line and that all train drivers are given training on how to slow down for wildlife sightings at certain hotspots along the railway.
